Re: March 2014 Monthly Progress Report
Administrative Settlement Agreement and Order on Consent for Removal Action
U.S. EPA Region 10 Docket No. CERCLA 10-2009-0255
Gasco Sediments Site within the Portland Harbor Superfund Site

Visual Observations Log Form

Monitoring Period: Monthly (Year 8)—March 2014

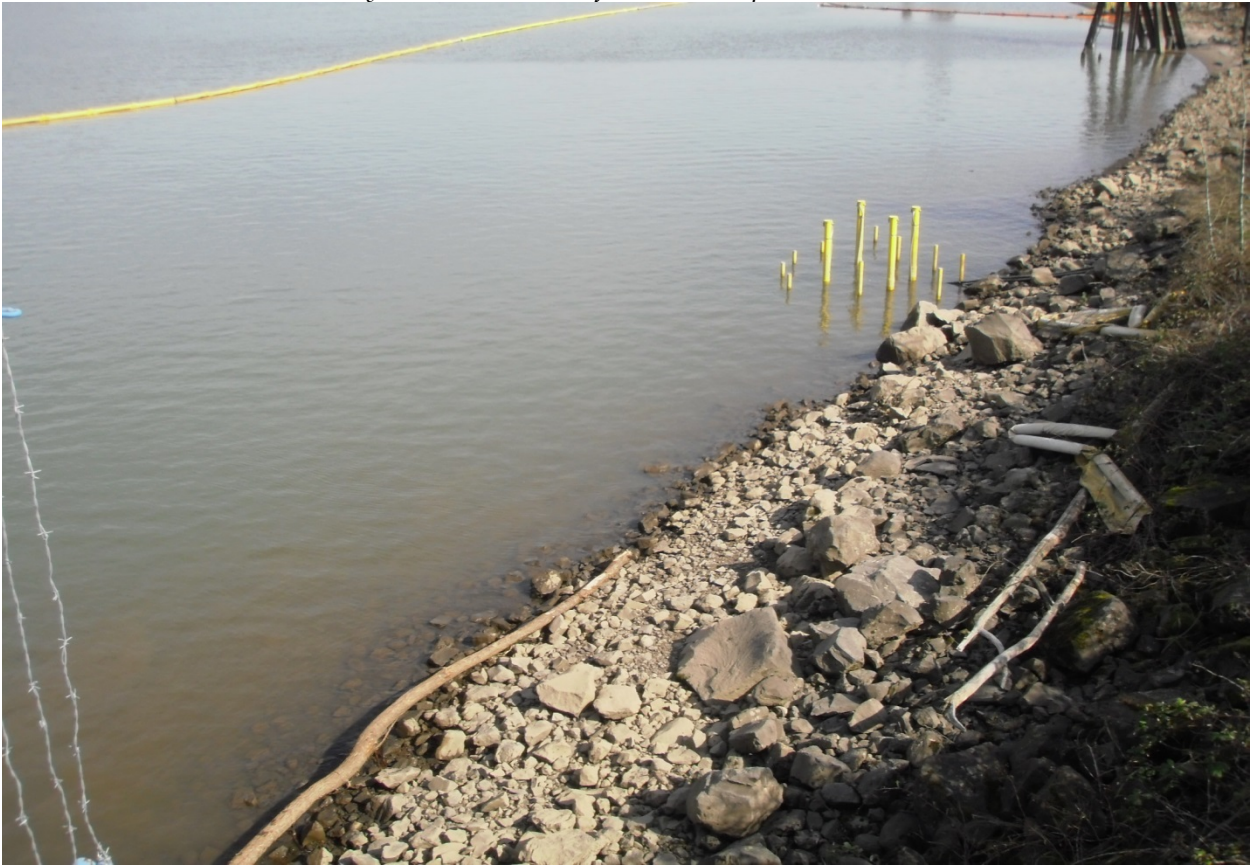
Observations of Erosion/Deposition: No erosion/deposition is evident along the shoreline. The shoreward extent of the cap was not visible due to high river water elevation and the extents of the organoclay mat material were also submerged. (Photo 1).

Photo 1 — *River level currently above the extent of sediment cap (3/24/14):*

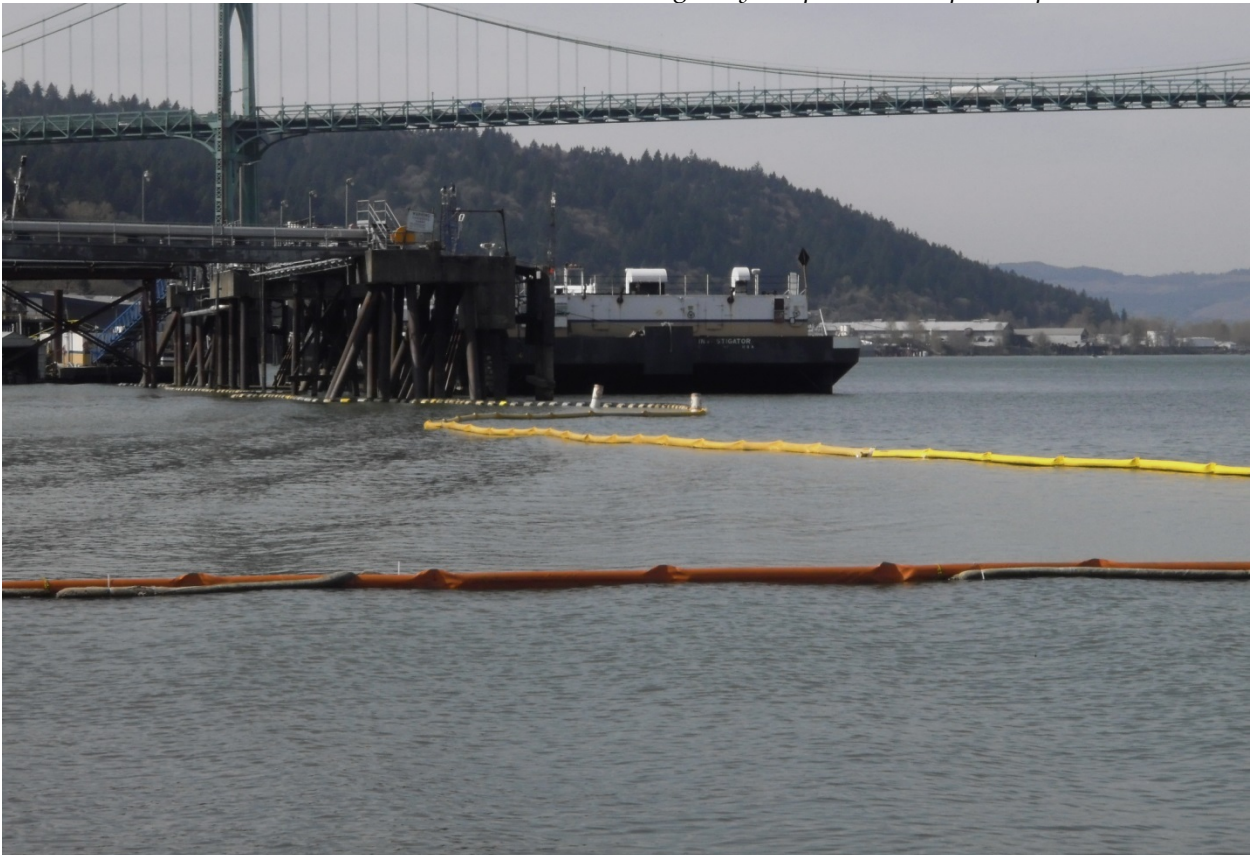
Observations of Long-term Controls (i.e., oil booms, organo-clay mat, etc.) During the observation, the Fuel and Marine Marketing (FAMM) containment boom was placed across the cap area, between the upriver corner of the ship dock and the wooden dolphin (near the upriver extent of the site and near the Siltronic Corporation outfall). Buoys that identify the cap area to mariners are in place as installed. The position of the FAMM oil boom, warning buoys, and a general overview of the site shoreline is shown in Photo 2.

Photo 2 — *FAMM oil boom shown and mariner warning buoys in place across pilot cap area. (3/24/14):*

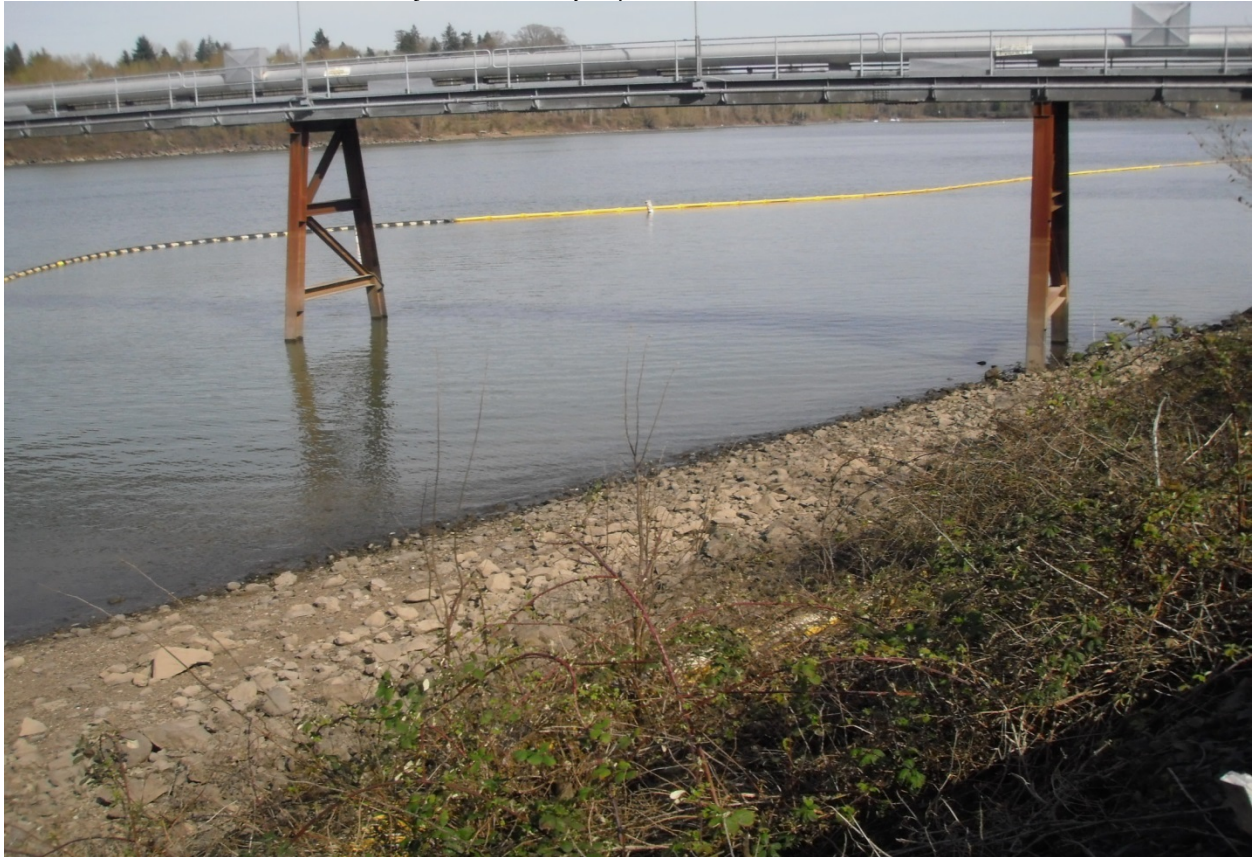
Other Comments: No sheen is evident in or around the cap area. Photo 3 shows the water surface and shoreline immediately downriver of the sediment cap.

Photo 3 — *Conditions immediately downriver of cap area (3/24/14):*
